2.0 Burrell, Pennsylvania, Disposal Site

2.1 Compliance Summary

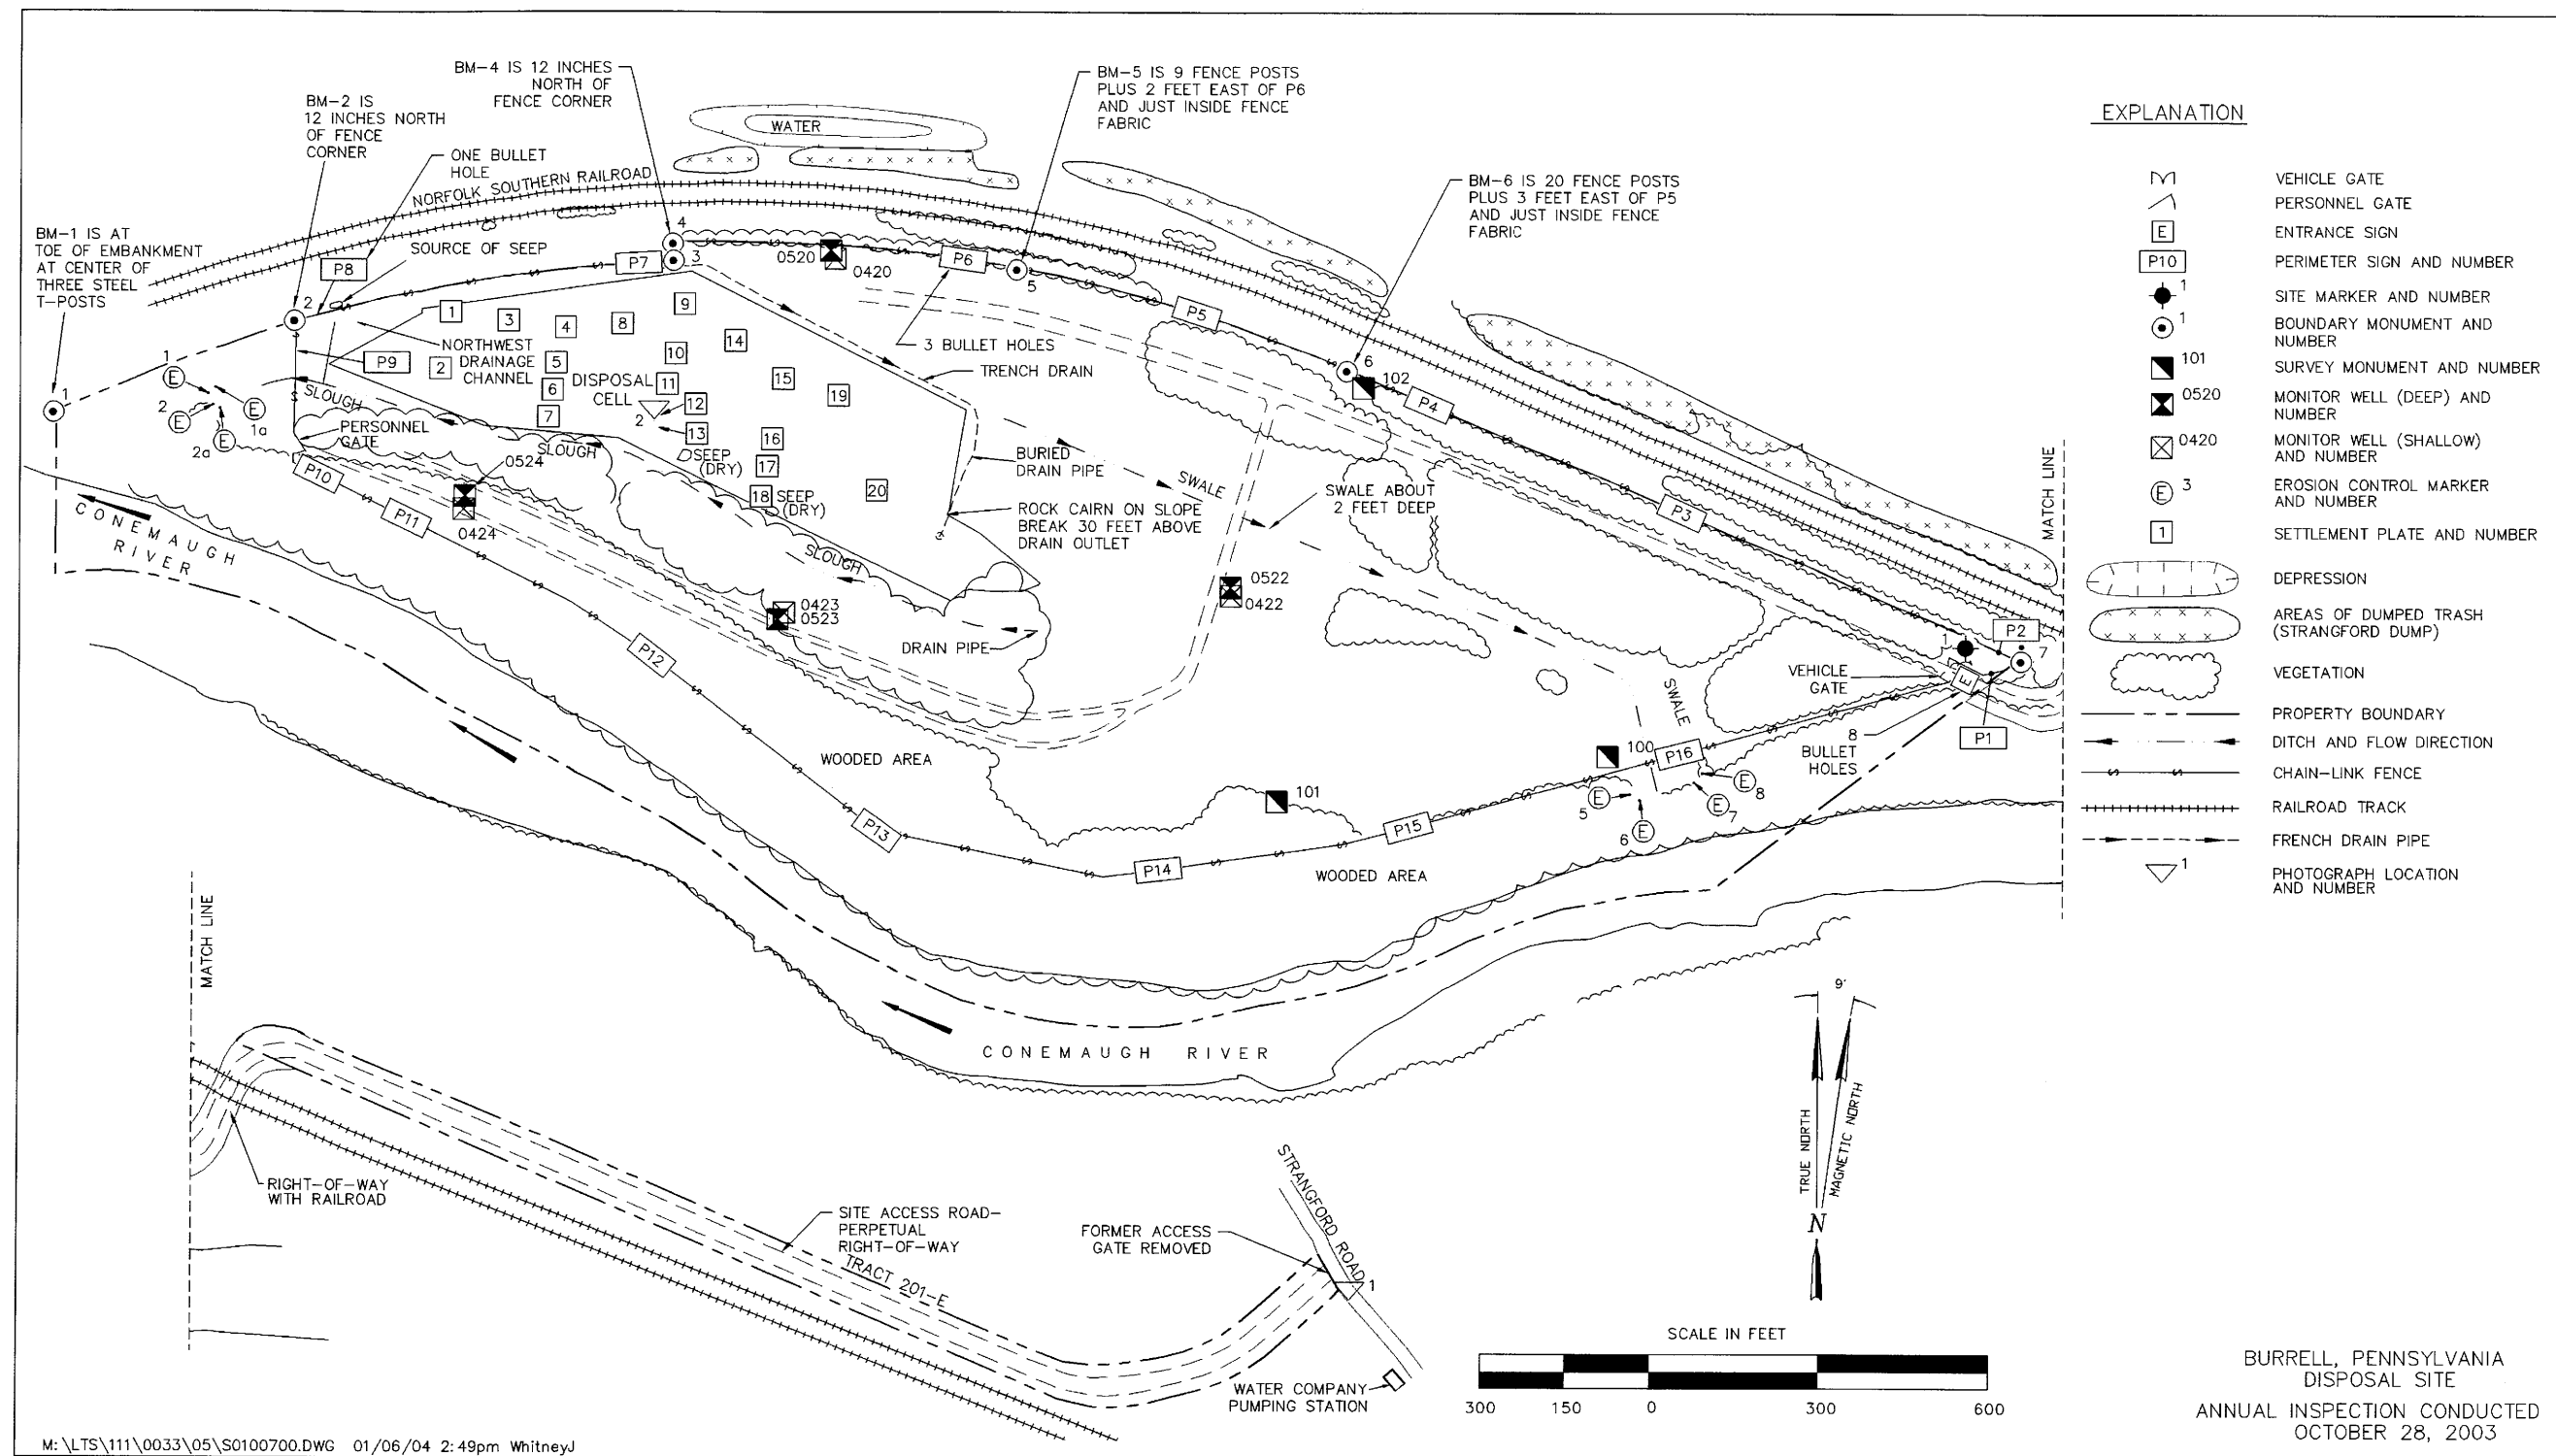
Figure 2-1. 2003 Annual Compliance Drawing for the Burrell, Pennsylvania, Disposal Site

The site, located southeast of Blairsville, Pennsylvania, was inspected on October 28, 2003. Results of the inspection are described below. Features and photograph locations (PLs) mentioned in this report are shown on Figure 2-1. Numbers in the left margin of this report refer to items summarized in the Executive Summary table.
